Contract #: 04-0120F4Cty: SF/ALA Rte: 80 PM: 13.2/13.9File #: 1.28**WELDING INSPECTION REPORT****Resident Engineer:** Casey, William**Address:** 333 Burma Road**City:** Oakland, CA 94607**Report No:** WIR-027741**Date Inspected:** 07-Jun-2012**Project Name:** SAS Superstructure**OSM Arrival Time:** 700**Prime Contractor:** American Bridge/Fluor Enterprises, a JV**OSM Departure Time:** 1930**Contractor:** American Bridge/Fluor Enterprises, a JV**Location:** Job Site**CWI Name:** See Below**CWI Present:** Yes No**Inspected CWI report:** Yes No N/A**Rod Oven in Use:** Yes No N/A**Electrode to specification:** Yes No N/A**Weld Procedures Followed:** Yes No N/A**Qualified Welders:** Yes No N/A**Verified Joint Fit-up:** Yes No N/A**Approved Drawings:** Yes No N/A**Approved WPS:** Yes No N/A**Delayed / Cancelled:** Yes No N/A**Bridge No:** 34-0006**Component:** OBG/Tower**Summary of Items Observed:**

WELDING INSPECTION REPORT

OBG E13 Drop-In Panels (SPCM)

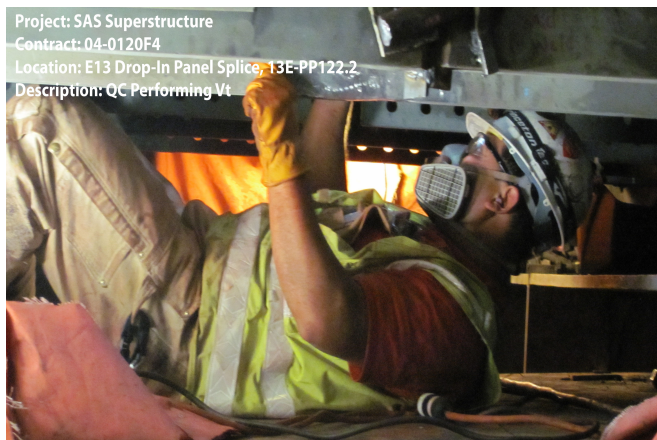
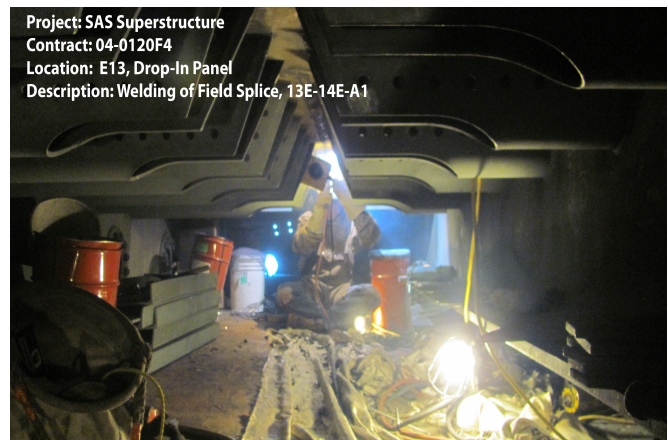
The QAI observed the Shielded Metal Arc Welding (SMAW) process of the structural steel floor beam field splice identified as Weld Number (WN): 13E-PP123-E2.8. The welding was performed by welding personnel, Steven Davis ID-7889 utilizing the Welding Procedure Specification (WPS) ABF-WPS-D15-1030, Rev. 1. The WPS was also used by the Quality Control (QC) Inspector Salvador Merino to verify the welding parameters and to monitor the welding of the Complete Joint Penetration (CJP) groove weld. The QAI observed the QC inspector verifying the welding parameters and were noted as 118 amps. The minimum preheat temperature of 40 degrees Celsius and the maximum interpass temperature of 230 degrees Celsius appeared to comply with contract documents. The welding was performed in the vertical (3G) position with the work placed in an approximately vertical plane with the groove approximately vertical.

The QAI also observed the Shielded Metal Arc Welding (SMAW) process of the drop-in panel field splice identified as Weld Number (WN): 13E-14E-A1. The welding was performed by welding personnel, Richard Garcia ID-5982 utilizing the Welding Procedure Specification (WPS) ABF-WPS-D15-1040-CU, Rev. 0. The WPS was also used by the Quality Control (QC) Inspector Salvador Merino to verify the welding parameters and to monitor the welding of the Complete Joint Penetration (CJP) groove weld. The QAI observed the QC inspector verifying the welding parameters and were noted as 128 amps. The minimum preheat temperature of 40 degrees Celsius and the maximum interpass temperature of 230 degrees Celsius appeared to comply with contract documents. The welding was performed in the overhead (4G) position with the work placed in an approximately vertical plane with the groove approximately vertical.

Later in the shift, the QAI observed the Shielded Metal Arc Welding (SMAW) process of the structural steel floor beam field splice identified as Weld Number (WN): 13E-PP123-E2.8. The welding was performed by welding

personnel, Khit Lounechaney ID-4985 utilizing the Welding Procedure Specification (WPS) ABF-WPS-D15-1030, Rev. 1. The WPS was also used by the Quality Control (QC) Inspector Salvador Merino to verify the welding parameters and to monitor the welding of the Complete Joint Penetration (CJP) groove weld. The QAI observed the QC inspector verifying the welding parameters and were noted as 135 amps. The minimum preheat temperature of 40 degrees Celsius and the maximum interpass temperature of 230 degrees Celsius appeared to comply with contract documents. The welding was performed in the flat (1G) position with the work placed in an approximately horizontal plane and the weld metal shall be deposited from the upper side.

This QAI also observed Mr. Merino perform the Magnetic Particle Testing (MPT) of the E13 drop-in panel field splice identified as WN: 13E-PP122.2. The testing was performed on the back gouge by the QC technician utilizing the MT Procedure identified as SE-MT-D1.5-CT-100 Rev.4. The QC technician performed the required test utilizing the parker contour probe in two directions (parallel and transverse to the weld axis). At the conclusion of the QC testing this QAI performed QA verification and no rejectable indication were noted. An MPT report identified as TL-6028 was generated on this date.

See digital photographs below illustrate some of the work observed during this shift.
